2 LAKE KIMBERLY DAM

3 NDI NO. PA-00949

PHASE I INSPECTION REPORT

NATIONAL DAM INSPECTION PROGRAM

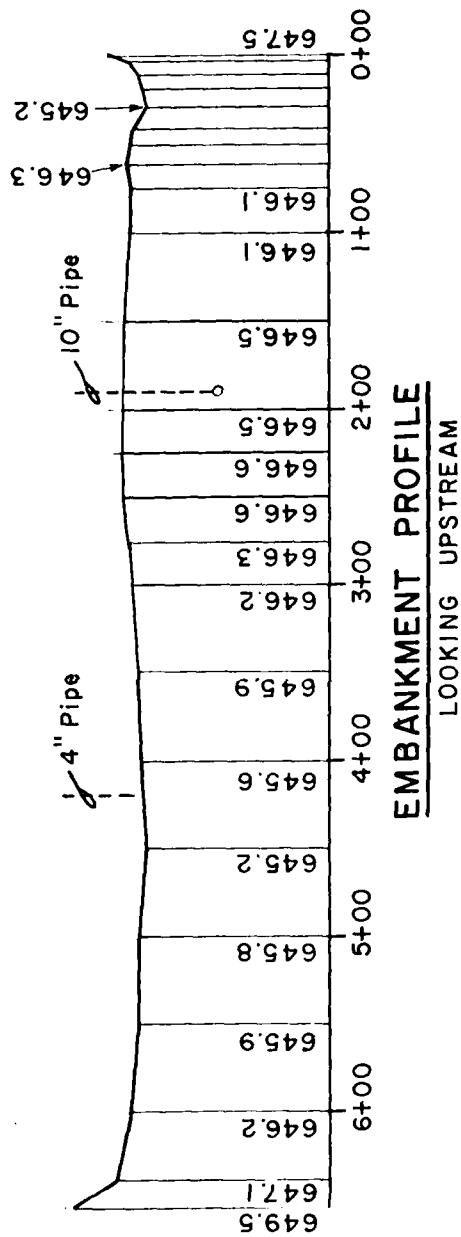
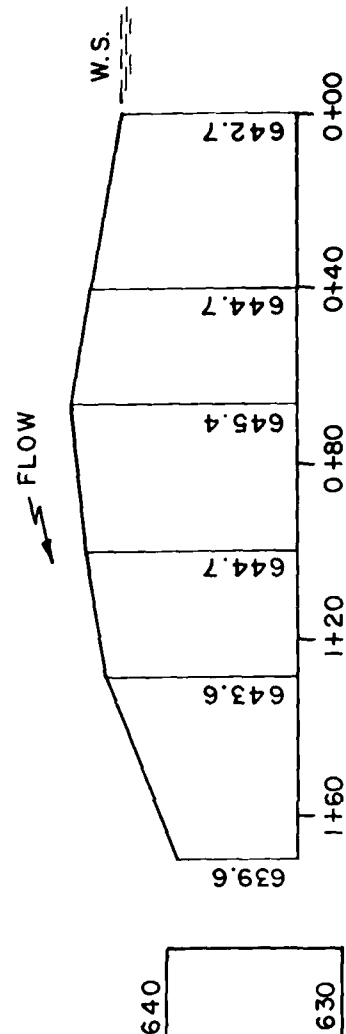
PLATE A-I

Records of operation are not maintained by the owner. Within one or two weeks after construction was completed, a slough occurred on the downstream slope in the area indicated on Plate A-I. This condition has not been improved nor repaired.

The downstream slope, near the left and right abutments, is flat and in good condition with a good grass mat protection, except where the bike trail has killed the grass. The center portion of the downstream slope is overgrown with trees, briars and brush (Photograph No. 4). In this area a 50 foot long slope failure was observed (Photographs No. 8 and 9 and Plate A-III, Appendix A). The owner stated that this slough occurred one or two weeks after construction was completed. Repairs were never made. Heavy brush in this area prevented close observation. Seepage was not detected during the inspection. The pool level was several feet below normal at that time. A woodchuck hole is located in this slough area.

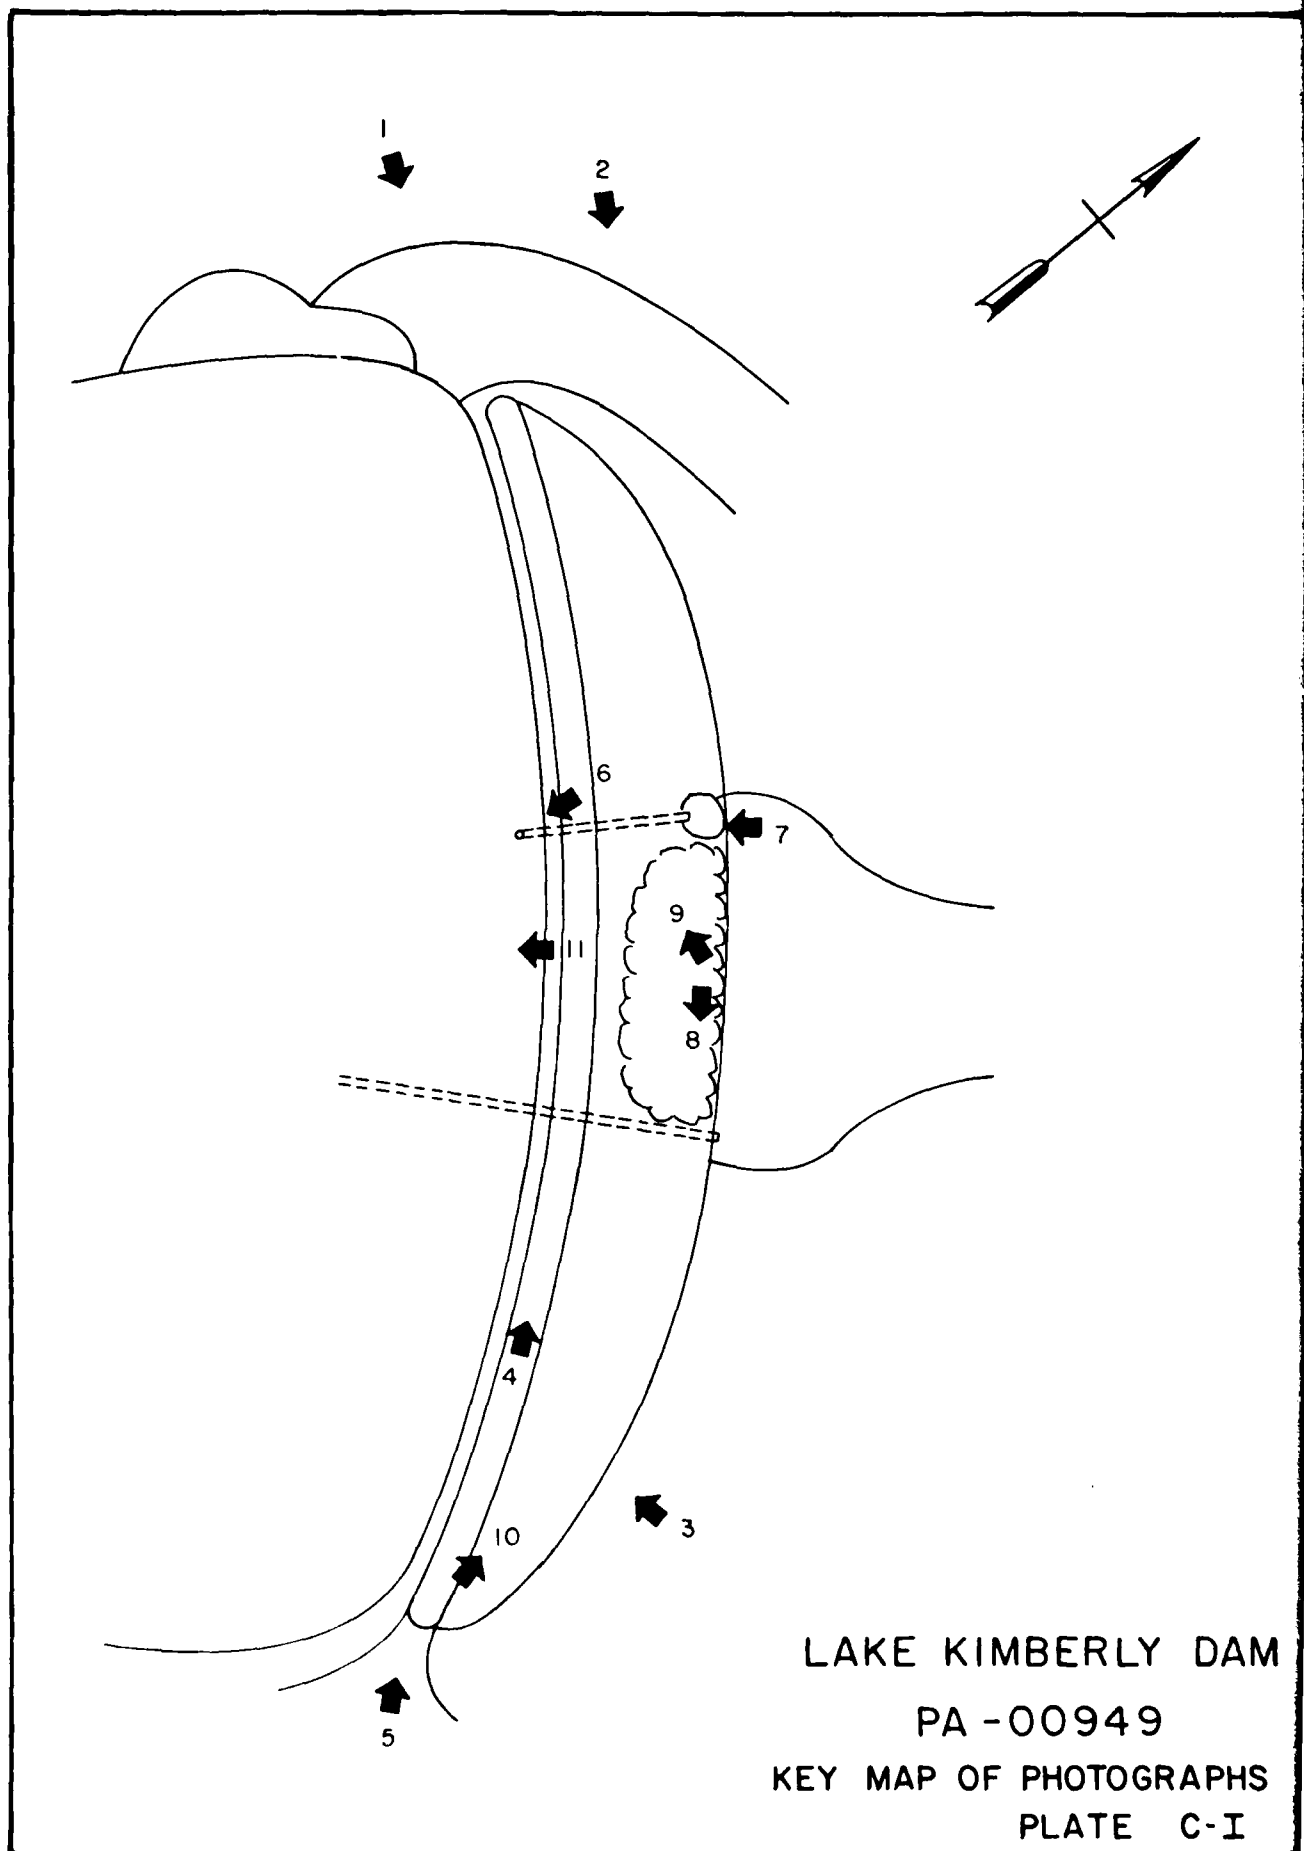
EMERGENCY SPILLWAY AND LEFT ABUTMENT - NO. 2

It was noted that the 9" drop inlet pipe was obstructed with a plastic container. There has been considerable erosion at the downstream end of the principal spillway discharge pipe. It was also noted that the emergency spillway crest was the same elevation as the low point in the embankment.
